2013 Annual Inspection Report

Bayou Chevee Shoreline Protection

State Project Number PO-22
Priority Project List 5

May 9, 2013
Orleans Parish

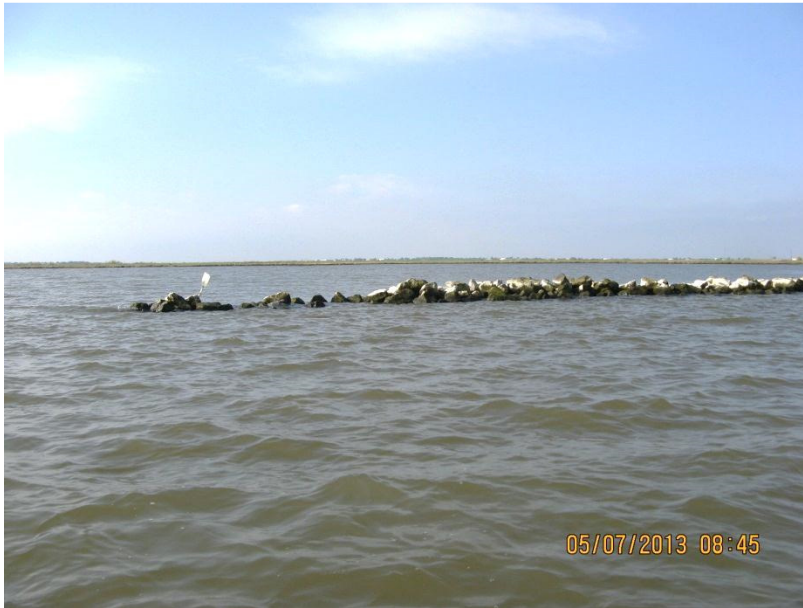
Photo #1 – Terminus of Southern Reach.

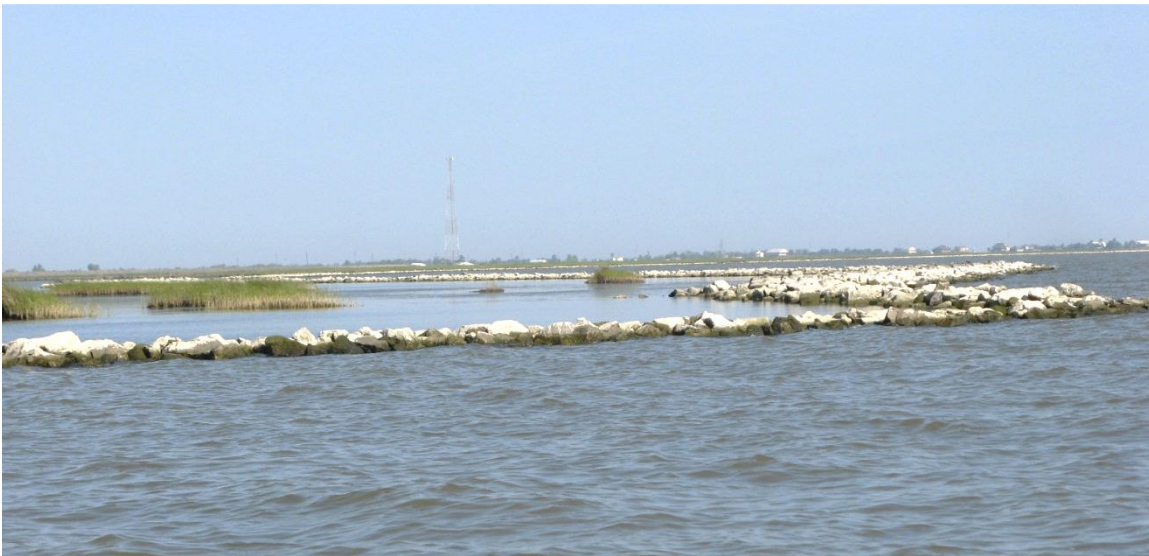
Photo #2 –Northern Reach.

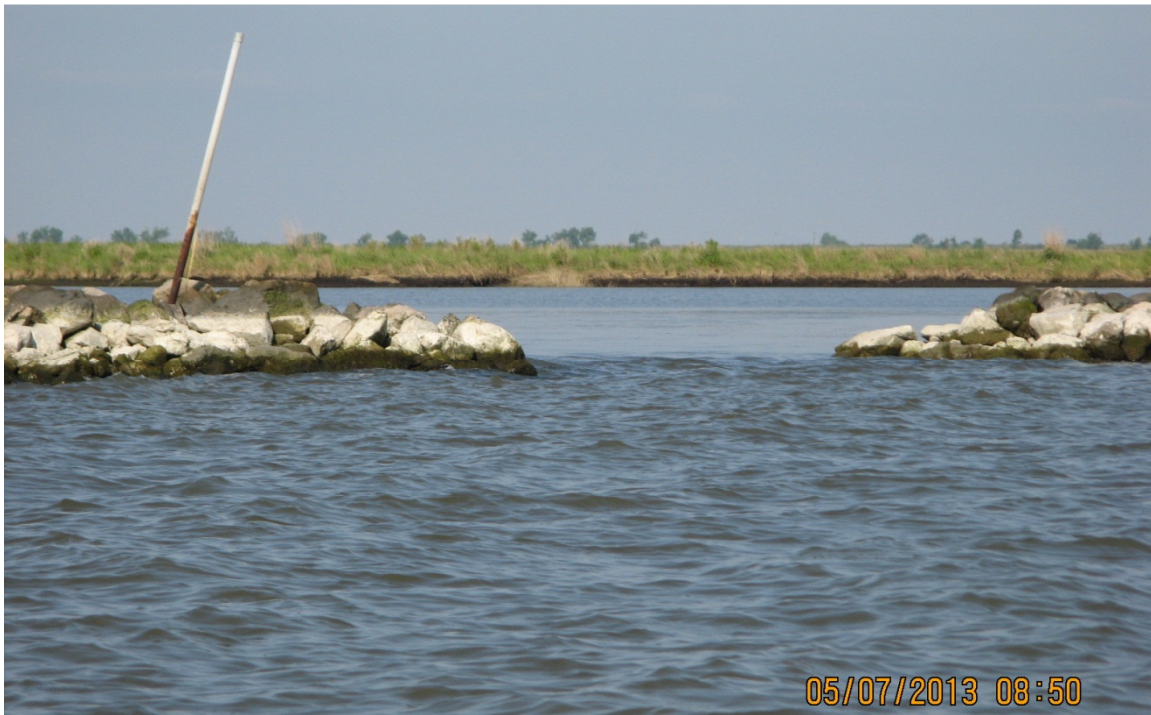
Photo #3 –Fish Dip, Northern Reach.

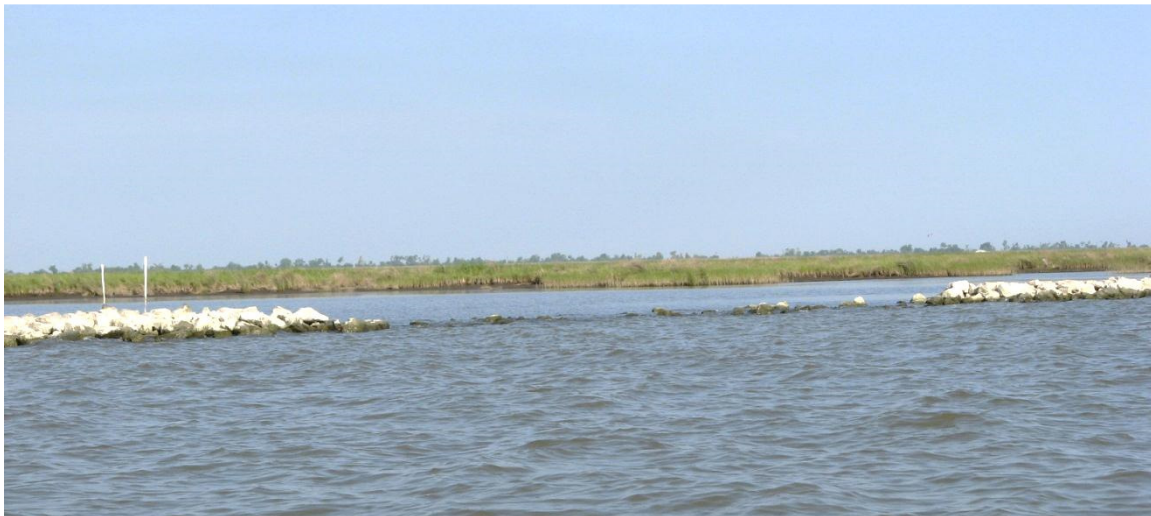
The low water conditions gave the inspection team a view of the entire north and south rock segments. Settlement noted during the 2011 inspection is still evident based on the waterline. The rock structure has maintained its shape although some sections were beneath the water surface. No mud waves or loose geotextile were noticed. The settlement plates at each fish dip are no longer in operable condition. This was noted during the March 2012 survey. There was no visible damage to the dikes. The southern reach and the southern portion of the northern reach are showing noticeable signs of settlement. The northern portion of the northern reach is still at an acceptable grade.

Photo #4 –Failed Section, Southern Reach.

The inspection team discussed a maintenance rock lift, which would require requests for additional funds due to the minimal amount of remaining funds. Additional improvements discussed were extending the rock dike to meet the headland of Chef Menteur Pass or dredge filling in the open water area behind the rock dike. The USACE performed a survey across the rock dikes and through the marsh. Water depths of 2-4 feet were noted. However, both recommendations would occur outside the existing project boundaries.

- Limited funds prevent maintenance at this time. The project team will meet to determine if future projects can address the recommendations discussed during this inspection.

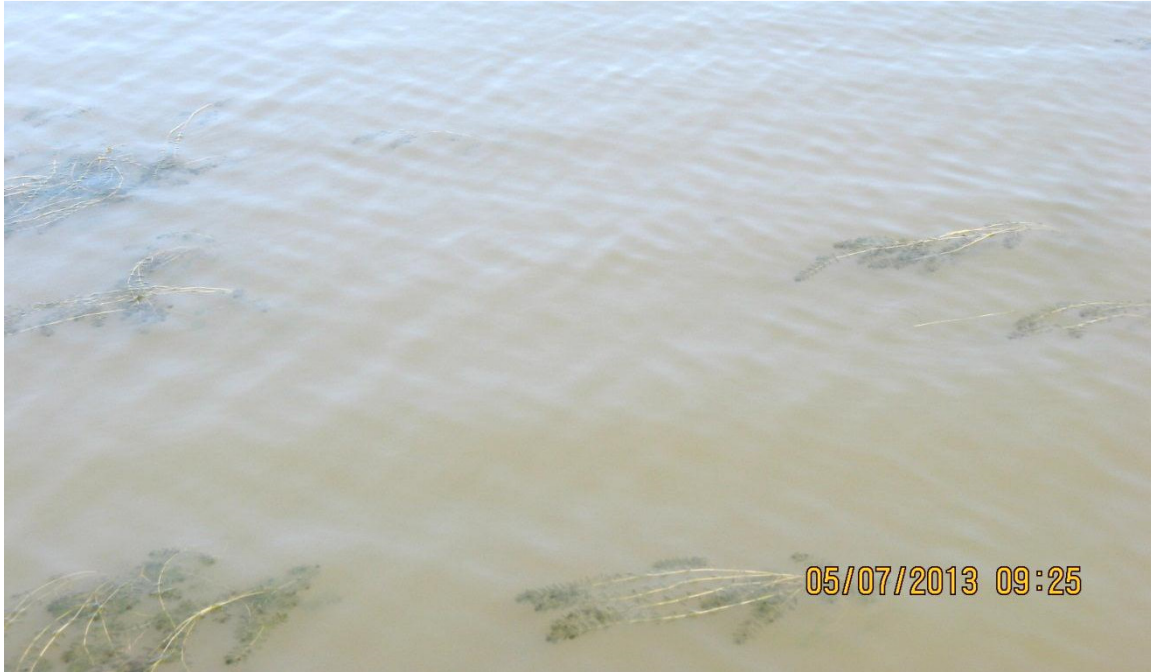
Photo #5 – Submerged Aquatic Vegetation behind rock dike

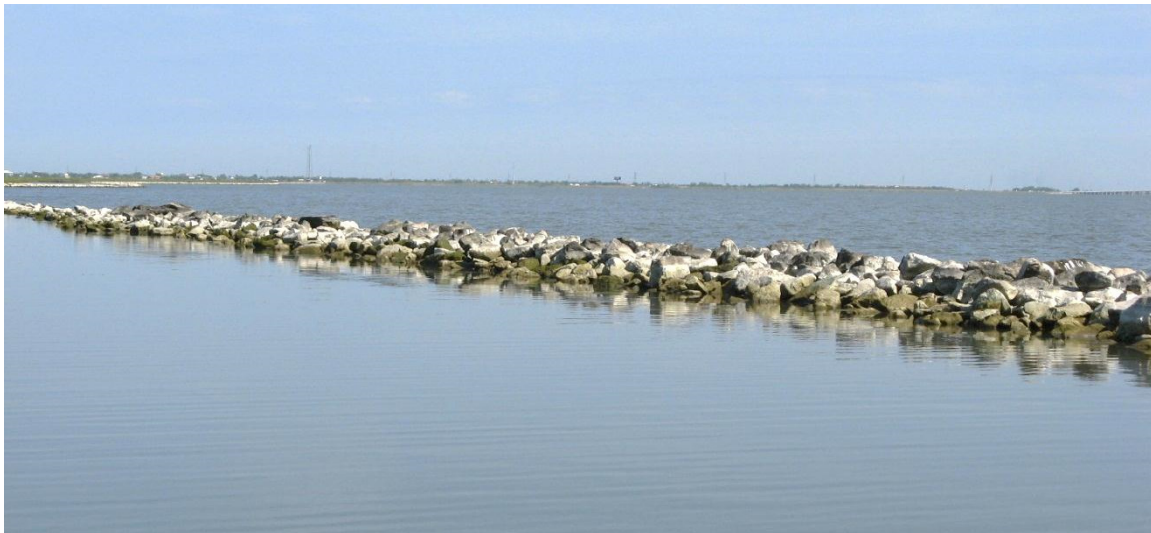
Photo #6 – Behind rock dike
